REKORD 2.0 E

3.1983
(Replaces Ed. 1.1982)

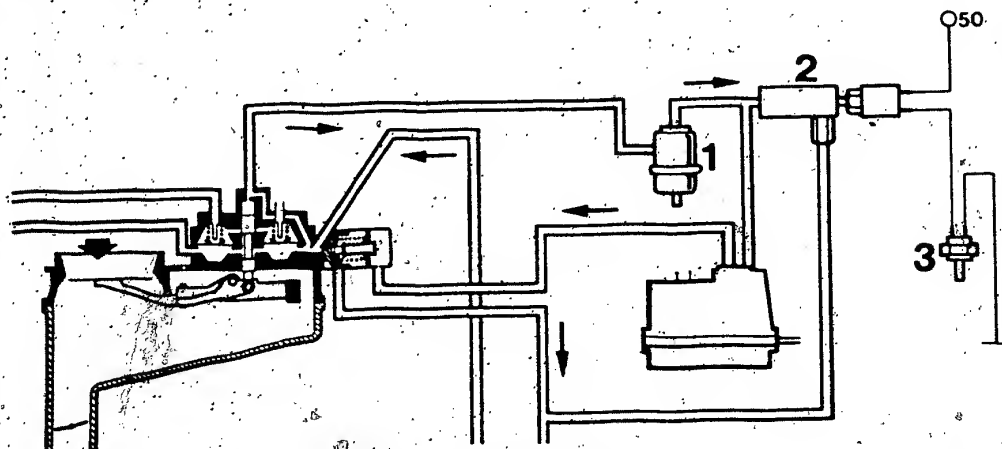
Fig. 1 1 = Fuel-line-pressure damper (see Section 2)
2 = Control-pressure-reduction valve
3 = Thermo-switch

Since, after switching off the engine at normal operating temperature, it is possible for vapor bubbles to form in the fuel-injection lines, advantages can be gained from reducing the control pressure when hot-starting. The thus increased fuel delivery accelerates the process of driving the vapor bubbles out of the injection lines and therefore improves the starting ability of the engine. This reduction in control pressure is brought about by the above-mentioned control-pressure-reduction valve.

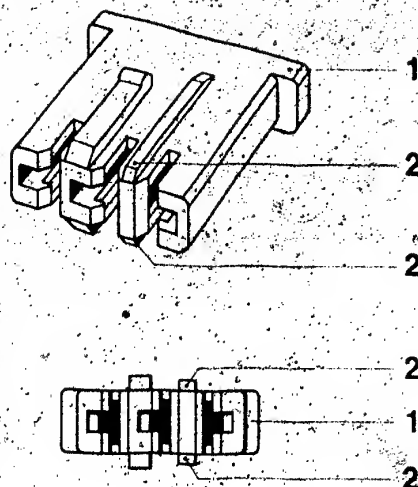
Fig. 1 - old design

1 = ignition-distributor connector
2 = long, narrow guide noses to be removed
